Research of the Existing Post-tensioned Roof Trusses and their Reliability

Abstract

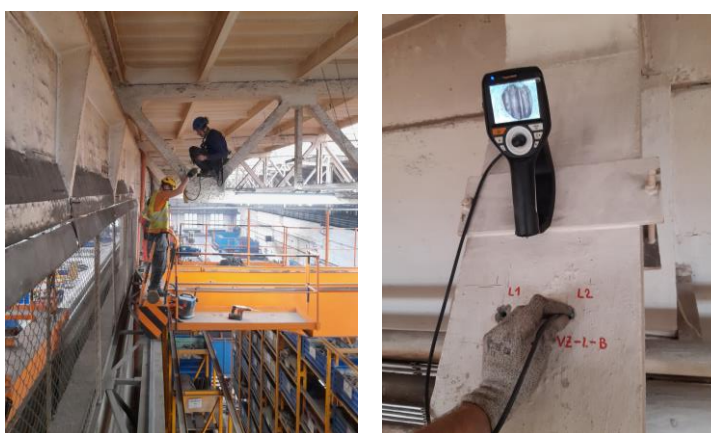
Fig. 7. Endoscopic survey of the truss tendons

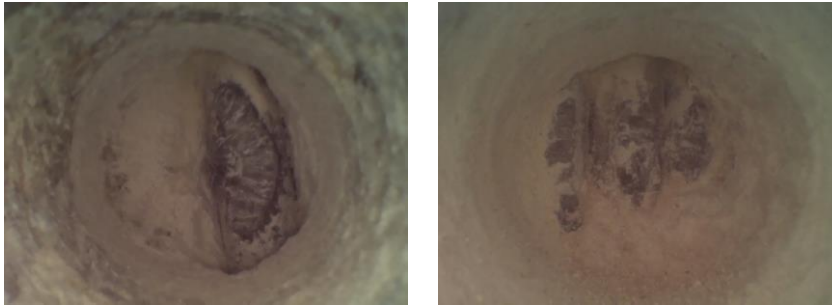
Fig. 8. Tendon ducts are fully grouted - G

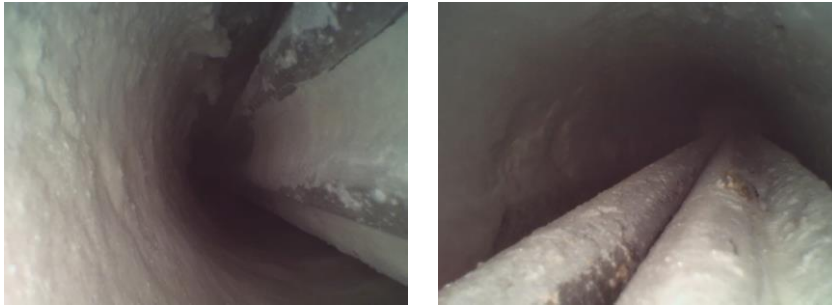
Fig. 9. Tendon ducts without grouting, tendons without corrosion – corrosion grade 1

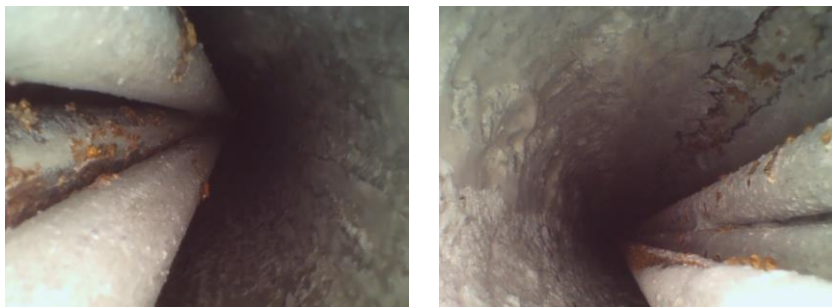
Fig. 10. Tendon ducts without grouting, local corrosion + leak marks – corrosion grade 2

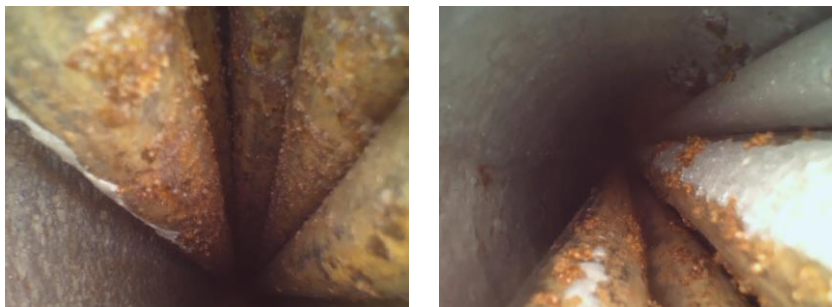
Fig. 11. Tendon ducts without grouting, surface corrosion – corrosion grade 3

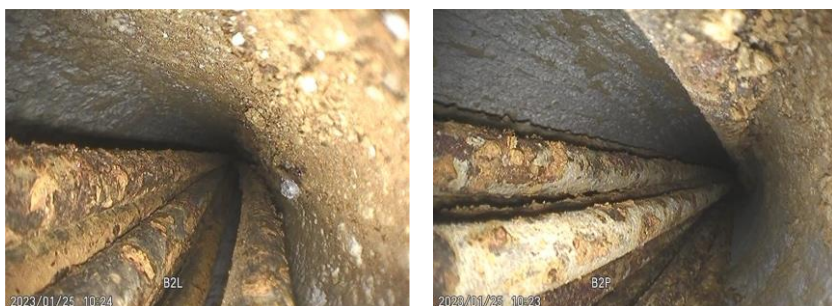
Fig. 12. Tendon ducts without grouting, surface corrosion – corrosion grade 5

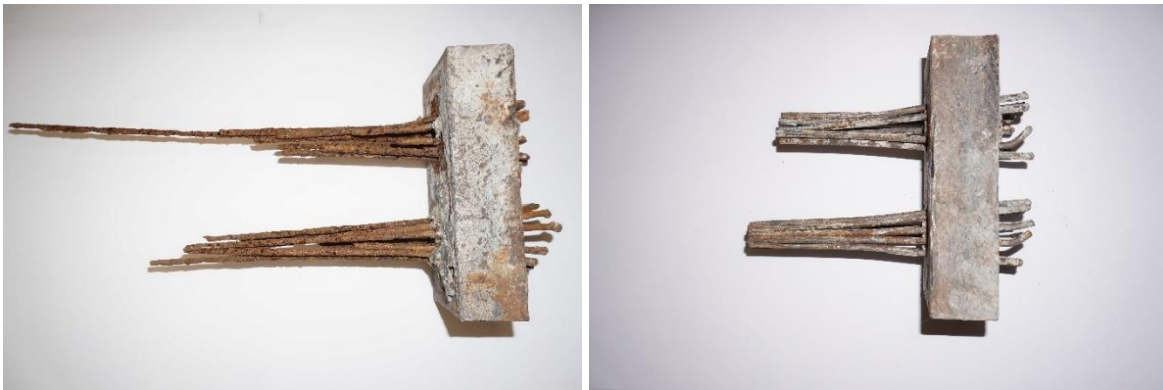
Fig. 13. The upper anchor in the location of the truss bedding on the column –
– total corrosion of the tendons and opposite side in the relative satisfying condition –
taken out from the collapsed truss

In the case of the collapse of the roof truss, from which the anchor of the prestressing reinforcement was taken according to FIGURE 13, the failure of the prestressing reinforcement occurred in close proximity to the upper anchor at the location of the truss bedding on the column. There are suspicions that in other known cases of collapse of structures of this type, failure of the anchorage areas occurred. Therefore, it seems that one of the other desirable directions of research should be the investigation of the condition of the anchorage areas and the investigation of the behavior of the truss during failure in the anchorage area of the prestressed reinforcement.
