Applications of Low-ceiling Photogrammetry Using UAV to Verify the Thickness of a Mineral-asphalt Package

The research attempted to verify the usefulness of low-ceiling photogrammetry for assessing the uniformity of the thickness of the mineral-asphalt package on the example of an experimental research site.

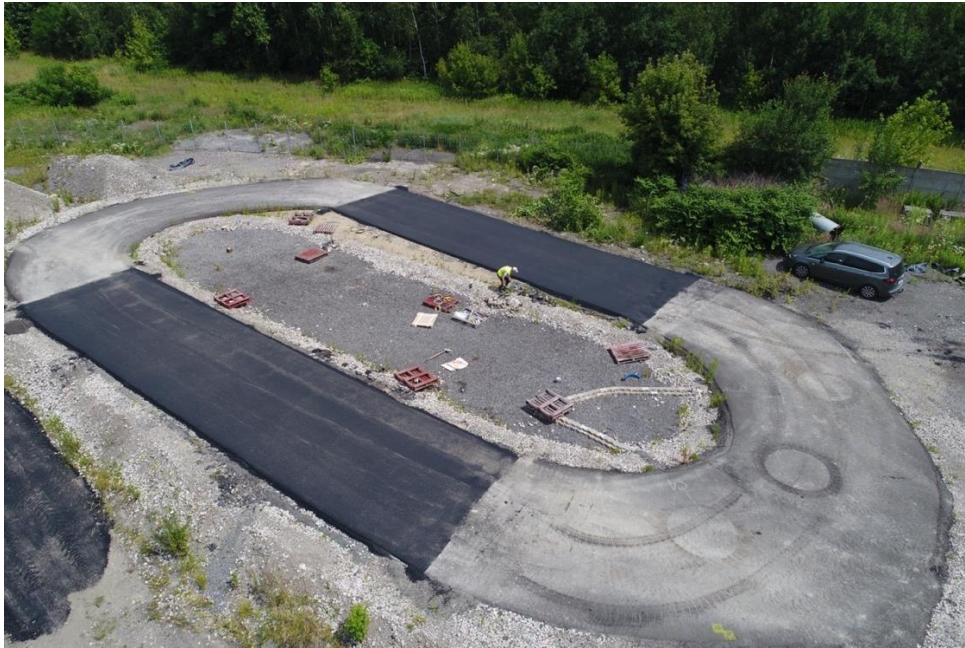
The research site was a separate track with circular traffic (Figure 1). The total length of the track was 85 m. In cross-section, the width of the lane was 3.5 m.

Fig. 1. View of the research site.

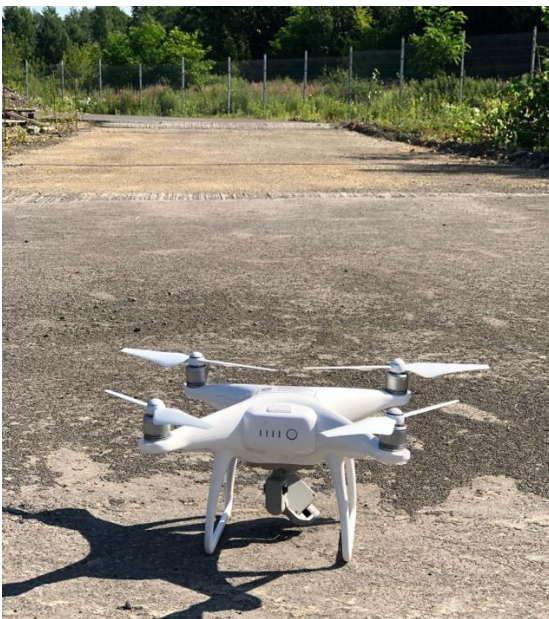
Field tests to verify the thickness of the mineral-asphalt package were performed using low-ceiling photogrammetry. An unmanned aerial vehicle (commonly a drone) was used for this purpose. The research was reduced to two measurement missions: before and after the installation of the mineral-asphalt mixture package. The measurements involved taking a series of photos, which were then processed using a specialized program. Point clouds were generated in which each measurement point in the field received x, y and z coordinates. The flights were carried out using a quadcopter weighing over 1.3 kg. The drone was equipped with a camera with a 1-inch 20 MPix matrix (Figure 2a)

Fig. 2. a) Preparing the drone for measurement - before applying the mineral-asphalt mixture, b) measurement of control points using GNSS satellite technology.

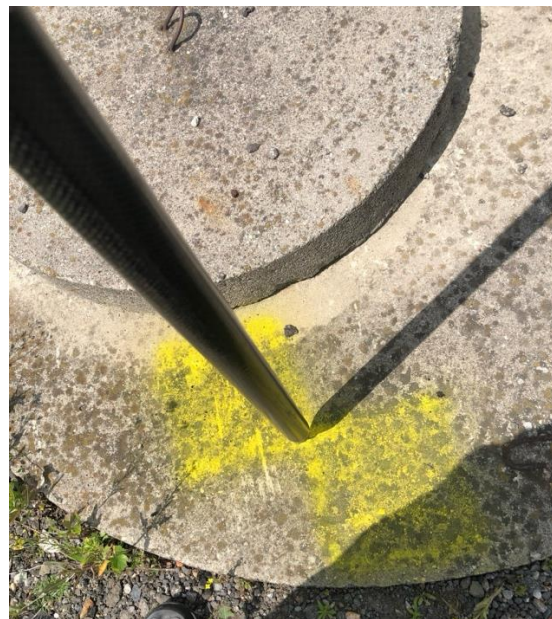
Photogrammetric processing began with aligning the photos and identifying ground control points - previously measured using GNSS (Figure 2b). This stage allowed for the generation of dense point clouds. The obtained 3D models of the zone of the tested pavement section are shown in Figure 3.
