Understanding and Addressing On-Site Moisture Protection Challenges in Timber Construction: A Comprehensive Review of German Practices

Kai Schubert^{1*)}, Claudia von Laar²⁾, Henning Bombeck³⁾

^{1*)} University of Applied Sciences Wismar, Philipp-Müller-Str.14 23966 Wismar, Germany, e-mail: kai.schubert@hs-wismar.de

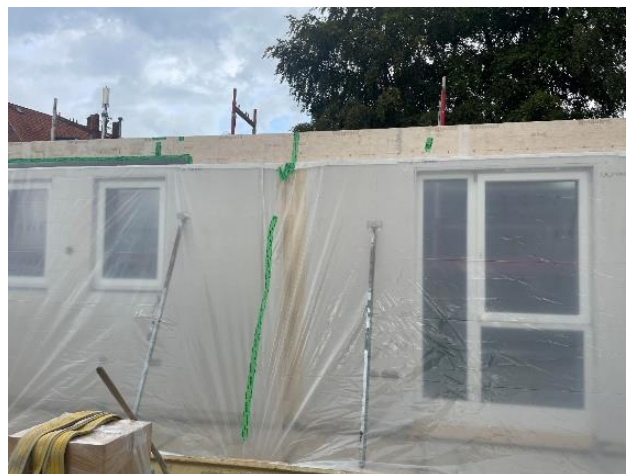
Fig. 1. Carefully protected element before ceiling is assembled in hybrid construction

The wall in Fig. 1 is carefully secured from all sides to protect the structure over the course of time until the ceiling is finished. The

wall is constructed as a timber-framed structure with a finished façade on the exterior and gypsum fiberboard on the interior. To protect the materials and elements from moisture ingress, the components were safeguarded at the factory against moisture penetration from both the top and the bottom. This was achieved by covering the top and bottom with a fully adhesive membrane to protect against moisture intrusion. Once the elements were erected, they were shielded from driving rain on the interior side using large-format films. This protective measure ensured the quality of the building components could be maintained over extended periods.

This is one of only two examples where the protection of elements has been tailored into a holistic concept to tackle the particular challenges that arose from the construction. Roughly half of the sites (47.6%) protected the top of prefabricated elements. This measure involves various applications such as sealing material joints with water-repellent tape, covering the top with tarpaulins, or utilizing fully bonding membranes. Shielding the components from above acts as a barrier against water ingress.

This protection is especially critical for timber-framed structures, where the insulation must be kept dry. Furthermore, only 33.3% of the sites protected the underside of elements against moisture. This solely focuses on protecting the lower parts of the wall structures from moisture accumulation through direct contact with water. Even fewer companies (19.0%) utilized lateral protection, all of which protected the sides with sheeting attached to the element to direct rainwater away from the surface. This measure, though less common, is crucial, especially in scenarios where walls are particularly vulnerable. In the case of timber frame construction, a way to protect the outer sides of prefabricated wall units is to trim the bottom layers, which for instance consist of Oriented Strand Board (OSB), gypsum board, or gypsum fiberboard, by approximately ten to twenty millimeters at the bottom. This trimming prevents the board from being immediately exposed to liquid water when the structure is subjected to rain and water collects on the floor. However, it is still necessary to ensure that the OSB board itself is not continually exposed to rainfall. This can be achieved by covering it with tarps and sheets (Fig. 1).

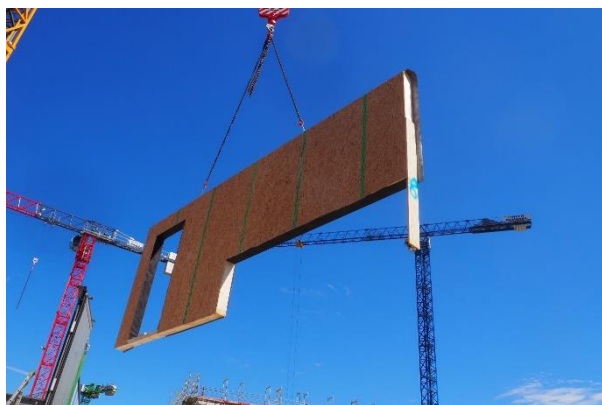
Figure 2. Wall section transferred by crane without pre-installed protection

When the components are delivered to the construction site, they are ideally protected to prevent them from getting wet during shipping. However, transferring the elements from the transportation vehicle to the eventual installation location poses a challenging interface where the components are often unprotected. This challenge is particularly pronounced in urban environments, where crane scheduling for larger construction projects is tightly managed due to limited space and strict timelines. As a result, the components must be lifted out of protective coverings or tarpaulin trucks, regardless of weather conditions. In the lifting process depicted in Fig. 2, protection measures are typically minimal. However, there is one exception wherein a site covering tent with an integrated crane track is utilized, offering enhanced safety and efficiency. However, as no construction sites with such tents were observed in Germany, it can be assumed that these play a minor role in the construction process.

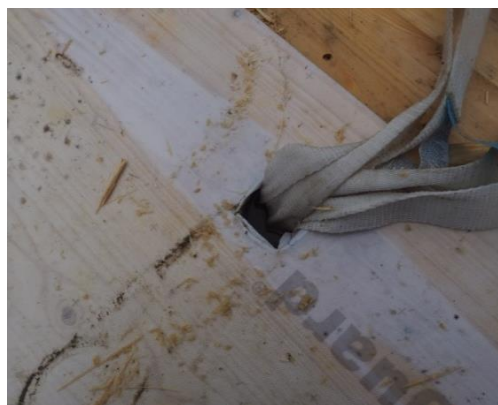
Figure 3. Blind holes pose a risk for the moistening of CLT elements

There are a number of different ways to lift the elements up. Depending on how the hooks are secured, covering the connections should be considered (ideally, everything has already been prepared beforehand, so that protection doesn't need to be evaluated on site; e.g. Fig. 3). Pockets (blind holes), for the crane loops should be protected by covers, if possible.

Otherwise, screwing on mounts for crane hooks is an alternative to be considered that can prevent moisture ingress because the element does not need to have large holes through which water can accumulate. After the element has been lowered, fastened and the hooks removed, the remaining holes should be covered with tape or otherwise protected. Otherwise, when water accumulates on the deck elements, a substantial amount can quickly infiltrate the otherwise protected component. The white discoloration in the Photograph is caused by the underlying moisture in the wood, indicating the extent to which water has penetrated via capillary action (around 35 cm in each direction with the grain). These situations pose an increased risk for undetected future damage. Such damage could potentially be mitigated or even prevented through extended drying times with proper ventilation and protection from additional moisture, or through preventive measures.

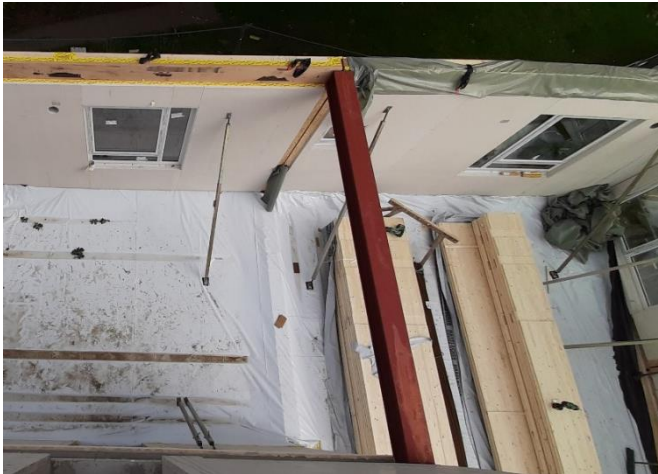
Fig. 4 illustrates an example of elements stacked before installation, and once assembled, shielded from potential rain by being covered with PE foil. The foil is tailored to the floor's shape and extends about 10 cm up the walls, with drainage through future installation shafts for collected water. However, it's crucial to safeguard the thin foil from punctures by dirt, tools, or screws. The foil's surface application allows for reusability or recyclability; however, it also permits moisture penetration through perforations, contrasting with fully bonded membranes that prevent water spread underneath.

Fig. 4. Ceiling elements and upper wall sections covered with foil

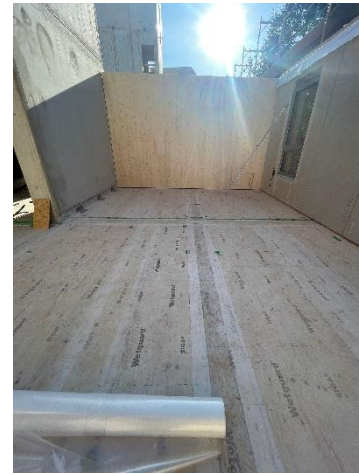
Fig. 5 shows a construction site where the elements were protected before installation. During the laying process, they were promptly covered using foil strips. This method is simpler and faster because the membrane is pre-installed. It also requires less careful handling and attention from the workers than solely using tarpaulins. However, although diffusion-open, membranes hinder the subsequent drying of any moisture that has penetrated.

Fig. 5. Ceiling protected by fully bonded translucent membrane

Especially in the adjacent areas, the membranes facilitate the rapid runoff of water, which can lead to a significant amount of water reaching the joints in a short period of time. For this reason, it is necessary to consider the potential implementation of a drainage system for larger surfaces.

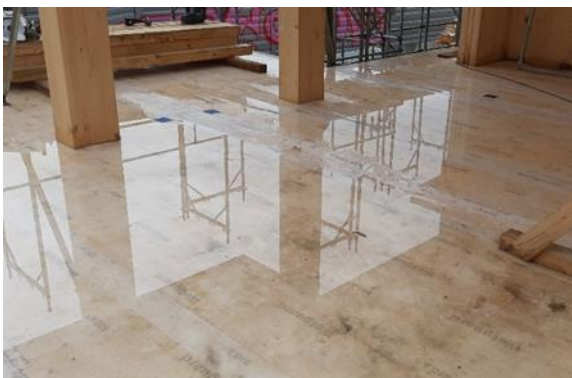
Fig. 6 shows a site where the ceilings have been protected from ingress with membranes, but the joints between the studs and the other walls have not been sealed. Initially, the necessary safeguards for the connections were not implemented, and subsequently, the studs and walls could accumulate water through the unsealed bottom end-grain. It was neither prevented that water could penetrate all floors (due to the large open structure) nor was there a plan for how to remove the water from the decks or where it should be drained.

Fig. 6. Water accumulation on undrained floor

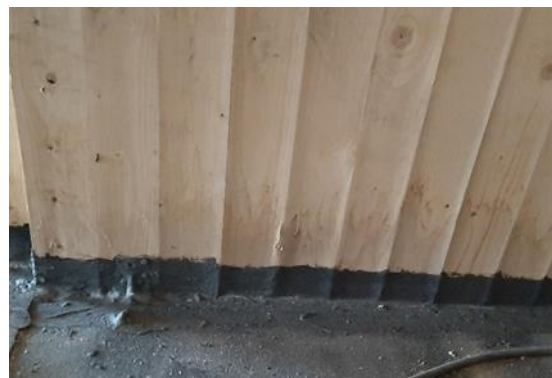
Fig. 7. CLT element after extensive exposure to water

Situations like this could be found in 50% (six sites without sealing to walls in 12 cases of solid wood ceilings) of all cases where walls had not been sealed to the horizontal parts of the structure. One possible solution to prevent water on horizontal structures is to use existing shafts to drain the floors. By dictating the path the water takes through the unfinished structure, there is less risk of water running over exposed edges and causing unnoticed dampness in the construction. In Fig. 7, a wall panel CLT is shown where no sufficient protection measures were implemented. While the component is protected against moisture at the bottom through bituminous sealing as a connection to the reinforced concrete floor slab, two different moisture pathways can be identified:

1. Capillary Action: The dark line at the bottom of the component indicates that it must have stood in water before the sealing

was applied. Wood substances were washed out, leaving these marks behind.

2. Exposure to Rain: The surface layer, which leaves the factory as a smooth plane, has taken on a wavy structure due to water absorption. The individual lamellae have expanded, causing this undulating appearance.

Before the interior construction can proceed, it must be ensured that the moisture within the component is monitored and can be released. If this does not happen, it is likely that moisture related damage will occur.
